**Flood Control Project Maintenance
Levee Inspections**
LMA District Cover Sheet
Spring 2020 Levee Inspection Results

Tehama County Flood Control and Water Conservation District

Waterway	Bank	Unit Miles
Unit No. 01 Deer Creek	Left	4.22

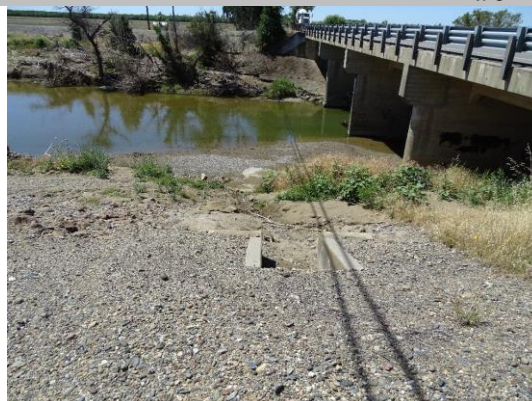
Photo 2 of 3 : UCIP_SP_2020_54123_79590.jpg

DS_ID:20773
 FS_ID:54123
 EP_NO: N/A
 Repair Type: Non-Urgent
 Crossing Status: Found
 UCIP Comments: 5/28/2019 Record updated from No Action Needed to Non-Urgent. No permit has been identified authorizing pipe.
 (O.Yakimov - DWR UCIP)
 FIELD_STRUCT_DESC: 24-inch corrugated metal drainage pipe through the levee, 5.1 feet below the crown. Flap gate and concrete U-shaped headwall on the waterside (WS) end. Concrete U-shaped headwall on the landside (LS) end. [Additional Reference(s): DWR Levee Log, 1992, (HLM 1.09). USACE Sacramento O&M Manual 510, March 1957 revised October 1964, (HLM 1.12) Drawing No. 50-4-3622].
 FS Date: 5/28/2019 11:34:16 AM

WS slope with concrete U-shaped headwall at the toe

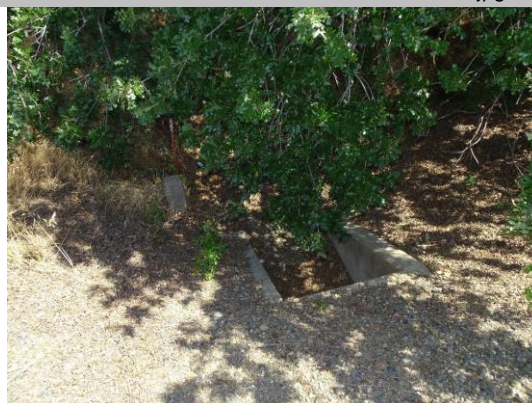
Photo 3 of 3 : UCIP_SP_2020_54123_79591.jpg

LS slope with concrete U-shaped headwall at the toe

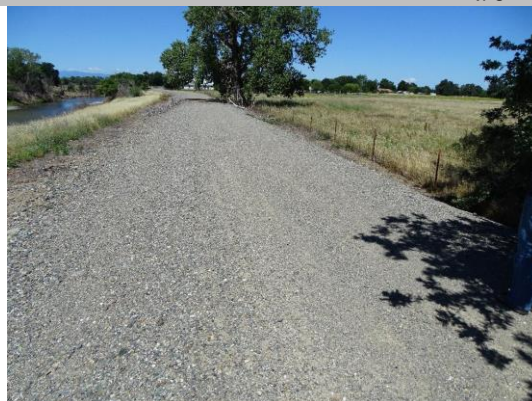
Photo 1 of 3 : UCIP_SP_2020_54124_79596.jpg

Comment Code						
Inspector Comment						
DS_ID:20782 FS_ID:54124 EP_NO: N/A Repair Type: Non-Urgent Crossing Status: Found UCIP Comments: 5/28/2019 Record updated from No Action Needed to Non-Urgent. No permit has been identified authorizing pipe. (O.Yakimov - DWR UCIP) FIELD_STRUCT_DESC: 24-inch corrugated metal drainage pipe through the levee, 5.0 feet below the crown. Flap gate and concrete U-shaped headwall on the waterside (WS) end. Concrete U-shaped headwall on the landside (LS) end. [Additional Reference(s): DWR Levee Log, 1992, (HLM 1.27). USACE Sacramento O&M Manual 510, March 1957 revised October 1964, (HLM 1.30) Drawing No. 50-4-3622]. FS Date: 5/28/2019 12:41:38 PM

View of levee crown at the crossing

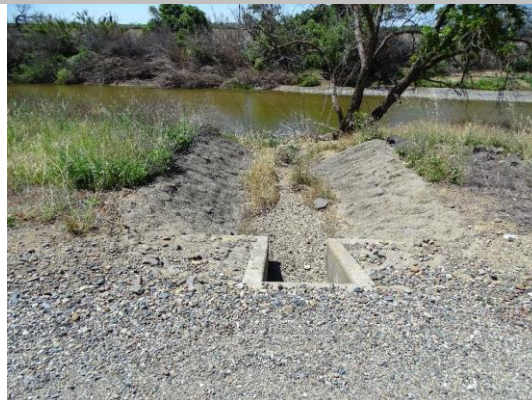
Photo 2 of 3 : UCIP_SP_2020_54124_79597.jpg

Water-Side

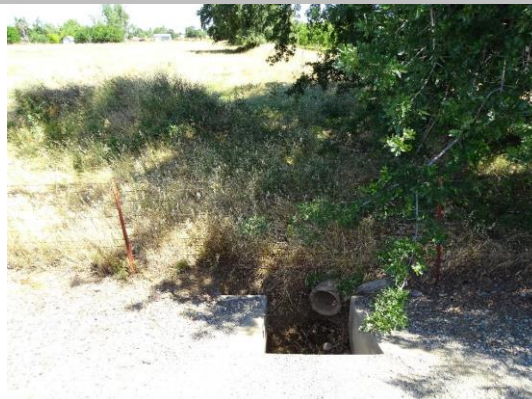
Photo 3 of 3 : UCIP_SP_2020_54124_79598.jpg

Land-Side

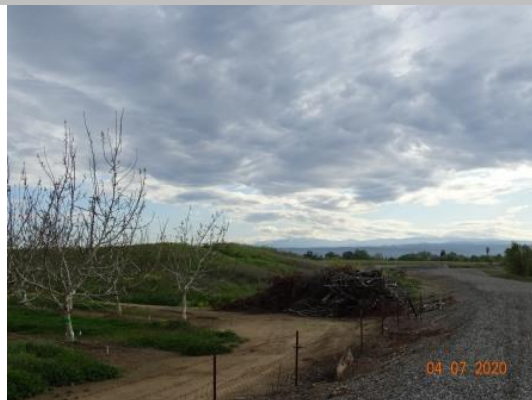
Photo 1 of 1 : SP_2020_NA0019_81_64_20200413_00085.jpg

LM Start	1.56	Rating **	M	Issue No.	64
LM End	1.56	Issue Type +	En	Location *	LS
Category	Earthen Levee			GPS Latitude/Longitude	
				Start	End
Item	Encroachments			40.052470 °	40.052470 °
				-122.162010 °	-122.162010 °
DWR ID	DWR_NA0019_04_s _ 2019_64				
Comment Code					
PR : Prunings					
Inspector Comment					
Remove prunings from the landside toe.

View of the prunings along the landside toe. Spring 2020.

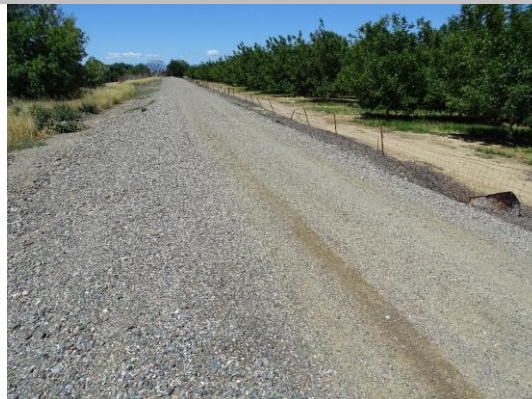
Photo 1 of 3 : UCIP_SP_2020_54125_79602.jpg

Comment Code						
Inspector Comment						
DS_ID:20783 FS_ID:54125 EP_NO: N/A Repair Type: Non-Urgent Crossing Status: Found UCIP Comments: 5/28/2019 Record updated from No Action Needed to Non-Urgent. No permit has been identified authorizing pipe. Pipe is partially filled with silt and debris. (O.Yakimov - DWR UCIP) FIELD_STRUCT_DESC: 24-inch corrugated metal drainage pipe through the levee, 5.8 feet below the crown. Flap gate and concrete U-shaped headwall on the waterside (WS) end. Concrete U-shaped headwall on the landside (LS) end. [Additional Reference(s): DWR Levee Log, 1992, (HLM 1.53). USACE Sacramento O&M Manual 510, March 1957 revised October 1964, (HLM 1.57) Drawing No. 50-4-3622]. FS Date: 5/28/2019 12:53:39 PM

View of levee crown at the crossing

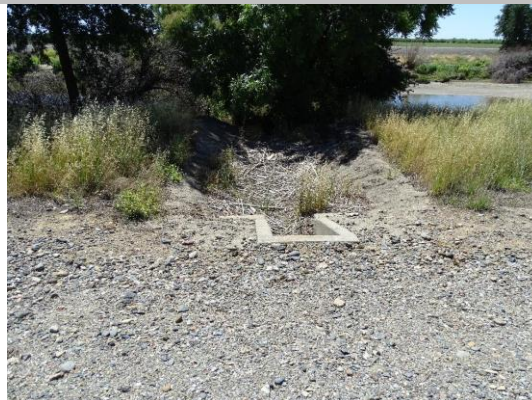
Photo 2 of 3 : UCIP_SP_2020_54125_79603.jpg

Water-Side

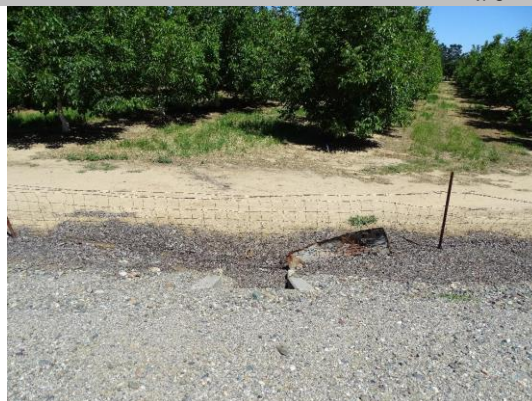
Photo 3 of 3 : UCIP_SP_2020_54125_79604.jpg

Land-Side

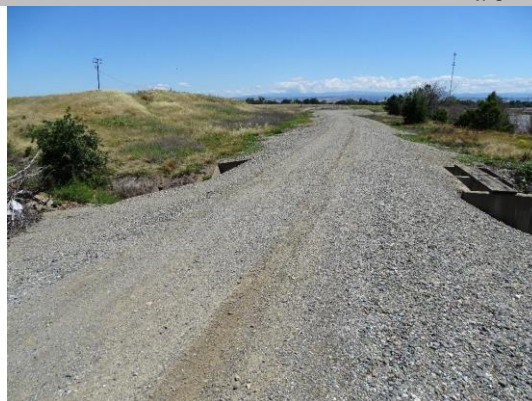
Photo 1 of 3 : UCIP_SP_2020_54126_79608.jpg

DS_ID:20784
 FS_ID:54126
 EP_NO: N/A
 Repair Type: Non-Urgent
 Crossing Status: Found
 UCIP Comments: 5/28/2019 Record updated from No Action Needed to Non-Urgent. No permit has been identified authorizing pipe. Debris at the outlet needs to be cleared for proper flap gate operation.
 (O.Yakimov - DWR UCIP)
 FIELD_STRUCT_DESC: 1 of 3: 36-inch reinforced concrete drainage pipe through the levee, 10.4 feet below the crown. Flap gate on the waterside (WS) end. [Additional Reference(s): DWR Levee Log, 1992].
 FS Date: 5/28/2019 1:10:12 PM

View of levee crown at the crossing

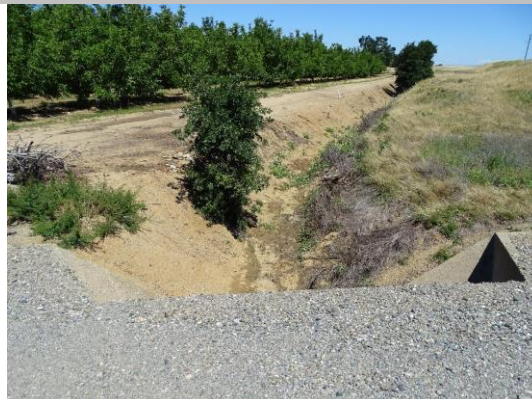
Photo 2 of 3 : UCIP_SP_2020_54126_79610.jpg

View of LS

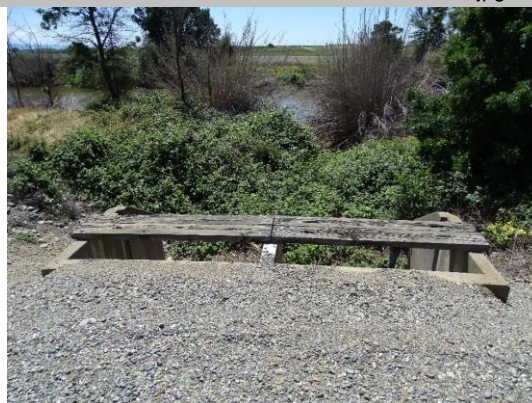
Photo 3 of 3 : UCIP_SP_2020_54126_79611.jpg

View of WS

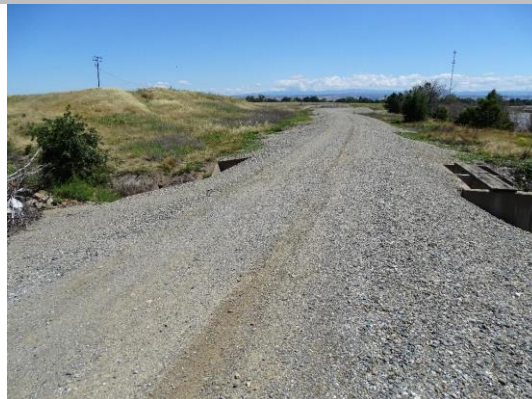
Photo 1 of 3 : UCIP_SP_2020_54127_79618.jpg

LM Start	1.58	Rating **	M	Issue No.	929
LM End	1.58	Issue Type +	En	Location *	
Category	Supplemental			GPS Latitude/Longitude	
				Start	End
Item	DWR UCIP Field Study			40.052603 °	40.052603 °
				-122.161640 °	-122.161640 °
DWR ID	20881				
Comment Code					
Inspector Comment					
DS_ID:20881 FS_ID:54127 EP_NO: N/A Repair Type: Non-Urgent Crossing Status: Found UCIP Comments: 5/28/2019 Record updated from No Action Needed to Non-Urgent. No permit has been identified authorizing pipe. Debris at the outlet needs to be cleared for proper flap gate operation. (O.Yakimov - DWR UCIP) FIELD_STRUCT_DESC: 2 of 3: 36-inch reinforced concrete drainage pipe through the levee, 10.4 feet below the crown. Flap gate on the waterside (WS) end. [Additional Reference(s): DWR Levee Log, 1992, (HLM 1.55)]. FS Date: 5/28/2019 1:11:26 PM

View of levee crown at the crossing

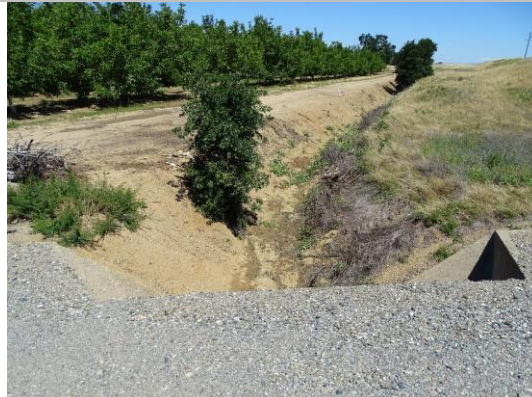
Photo 2 of 3 : UCIP_SP_2020_54127_79620.jpg

View of LS

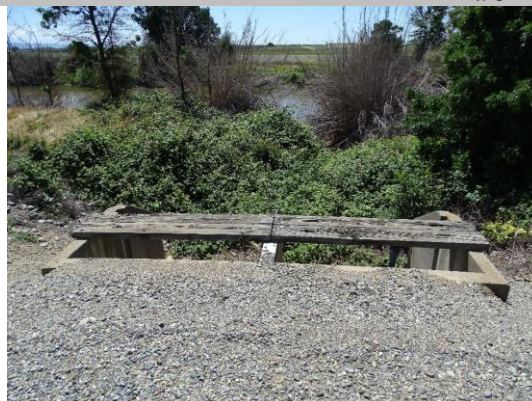
Photo 3 of 3 : UCIP_SP_2020_54127_79621.jpg

View of WS

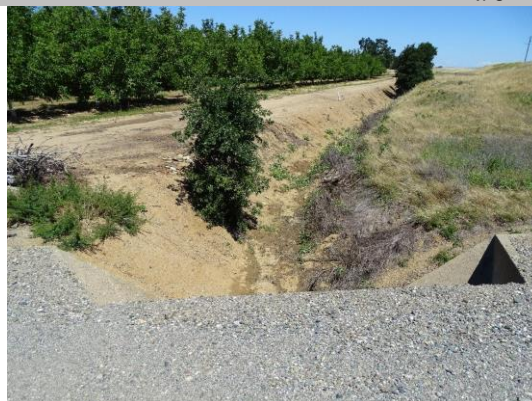
Photo 2 of 3 : UCIP_SP_2020_54128_79625.jpg

DS_ID:20882
 FS_ID:54128
 EP_NO: N/A
 Repair Type: Non-Urgent
 Crossing Status: Found
 UCIP Comments: 5/28/2019 Record updated from No Action Needed to Non-Urgent. No permit has been identified authorizing pipe.
 (O.Yakimov - DWR UCIP)
 FIELD_STRUCT_DESC: 3 of 3: 36-inch reinforced concrete drainage pipe through the levee, 10.4 feet below the crown. Flap gate on the waterside (WS) end. [Additional Reference(s): DWR Levee Log, 1992, (HLM 1.55)].
 FS Date: 5/28/2019 1:52:00 PM

View of LS

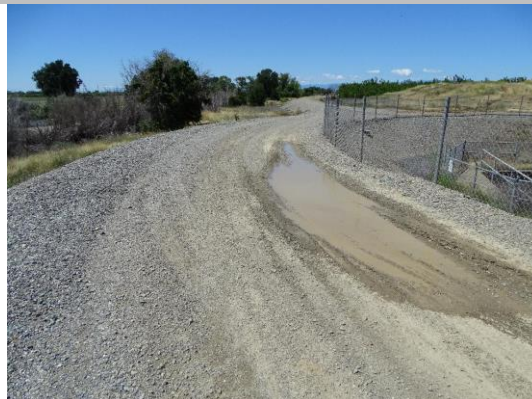
Photo 1 of 3 : UCIP_SP_2020_54129_79630.jpg

LM Start	1.65	Rating **	M	Issue No.	931
LM End	1.65	Issue Type +	En	Location *	
Category	Supplemental			GPS Latitude/Longitude	
				Start	End
Item	DWR UCIP Field Study			40.053149 °	40.053149 °
				-122.160463 °	-122.160463 °
DWR ID	20785				
Comment Code					
Inspector Comment					
DS_ID:20785 FS_ID:54129 EP_NO: N/A Repair Type: Non-Urgent Crossing Status: Found UCIP Comments: 5/28/2019 Record updated from No Action Needed to Non-Urgent. Unauthorized encroachment recorded in Levee Log prior to 2011. Water level in canal is too high to see siphon pipe. (O.Yakimov - DWR UCIP) FIELD_STRUCT_DESC: [Tehama-Colusa Canal] 18-foot reinforced concrete irrigation siphon pipe through the levee, 30 feet below the crown. [Additional Reference(s): DWR Levee Log, 1992, (HLM 1.63)]. FS Date: 5/28/2019 2:01:09 PM

View of levee crown at the crossing

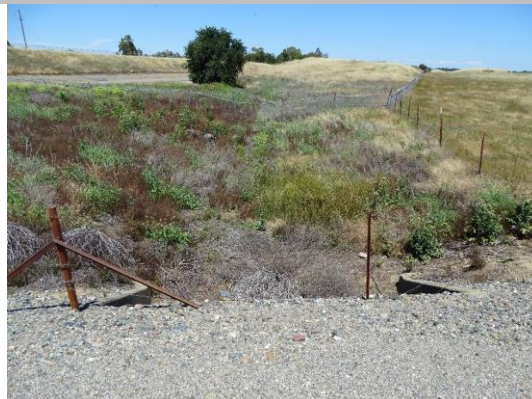
Photo 2 of 3 : UCIP_SP_2020_54130_79636.jpg

View of LS

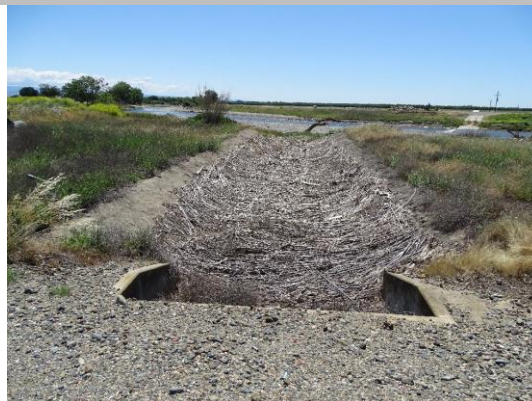
Photo 3 of 3 : UCIP_SP_2020_54130_79637.jpg

View of WS

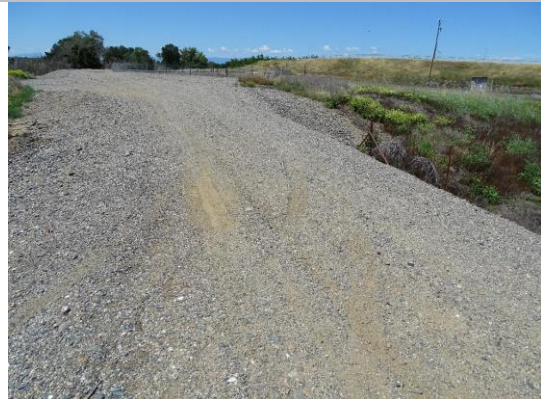
Photo 1 of 3 : UCIP_SP_2020_54131_79641.jpg

Comment Code						
Inspector Comment						
DS_ID:20883 FS_ID:54131 EP_NO: N/A Repair Type: Non-Urgent Crossing Status: Found UCIP Comments: 5/28/2019 Record updated from No Action Needed to Non-Urgent. No permit has been identified authorizing pipe. Brush at pipe outlet, but doesn't seem to affect flap gate operation. (O.Yakimov - DWR UCIP) FIELD_STRUCT_DESC: 2 of 3: 36-inch corrugated metal drainage pipe through the levee, 7.3 feet below the crown. Flap gate and concrete U-shaped headwall on the waterside (WS) end. Concrete U-shaped headwall on the landside (LS) end. [Additional Reference(s): DWR Levee Log, 1992, (HLM 1.66). USACE Sacramento O&M Manual 510, March 1957 revised October 1964, (HLM 1.70) Drawing No. 50-4-3622]. FS Date: 5/28/2019 2:24:53 PM

View of levee crown at the crossing

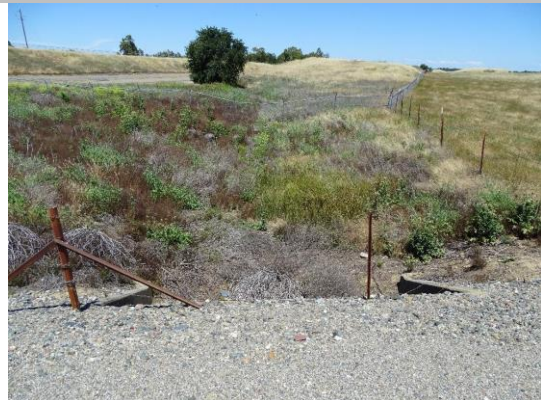
Photo 2 of 3 : UCIP_SP_2020_54131_79642.jpg

View of LS

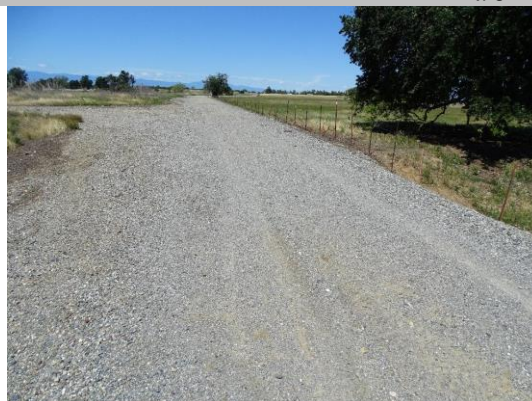
Photo 1 of 3 : UCIP_SP_2020_54133_79654.jpg

Comment Code					
Inspector Comment					
DS_ID:20787 FS_ID:54133 EP_NO: N/A Repair Type: Non-Urgent Crossing Status: Found UCIP Comments: 5/28/2019 Record updated from No Action Needed to Non-Urgent. No permit has been identified authorizing pipe. (O.Yakimov - DWR UCIP) FIELD_STRUCT_DESC: 1 of 2: 36-inch corrugated metal drainage pipe through the levee, 7.6 feet below the crown. Flap gate and concrete U-shaped headwall on the waterside (WS) end. Concrete U-shaped headwall on the landside (LS) end. [Additional Reference(s): DWR Levee Log, 1992, (HLM 1.96). USACE Sacramento O&M Manual 510, March 1957 revised October 1964, (HLM 2.01) Drawing No. 50-4-3622]. FS Date: 5/28/2019 2:33:09 PM

View of levee crown at the crossing

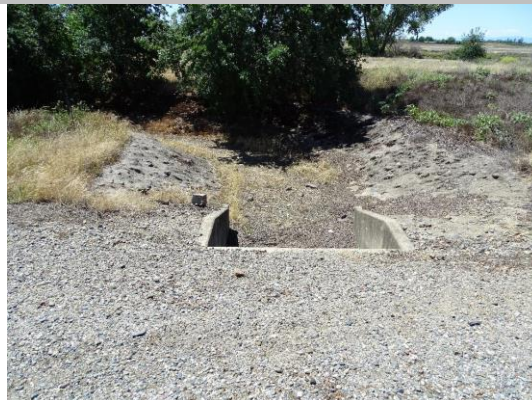
Photo 2 of 3 : UCIP_SP_2020_54133_79655.jpg

View of WS

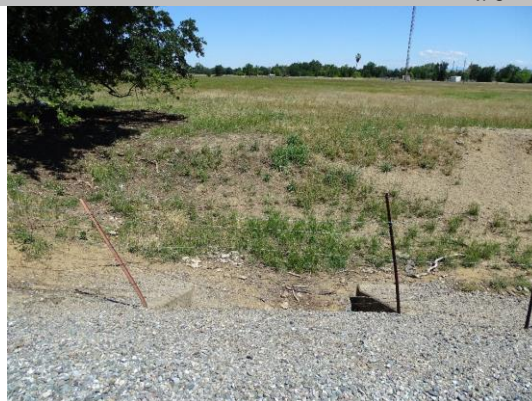
Photo 3 of 3 : UCIP_SP_2020_54133_79656.jpg

View of LS

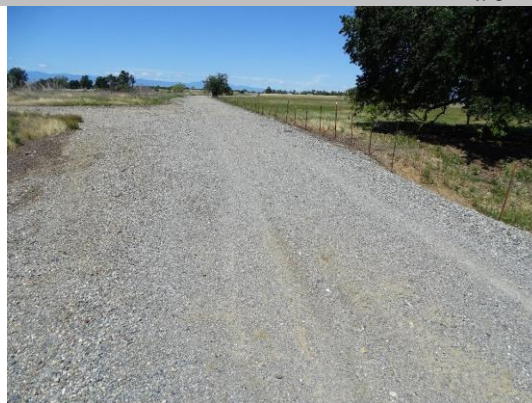
Photo 1 of 3 : UCIP_SP_2020_54134_79660.jpg

DS_ID:20885
 FS_ID:54134
 EP_NO: N/A
 Repair Type: Non-Urgent
 Crossing Status: Found
 UCIP Comments: 5/28/2019 Record updated from No Action Needed to Non-Urgent. No permit has been identified authorizing pipe.
 (O.Yakimov - DWR UCIP)
 FIELD_STRUCT_DESC: 2 of 2: 36-inch corrugated metal drainage pipe through the levee, 7.6 feet below the crown. Flap gate and concrete U-shaped headwall on the waterside (WS) end. Concrete U-shaped headwall on the landside (LS) end. [Additional Reference(s): DWR Levee Log, 1992, (HLM 1.96). USACE Sacramento O&M Manual 510, March 1957 revised October 1964, (HLM 2.01) Drawing No. 50-4-3622].
 FS Date: 5/28/2019 2:38:32 PM

View of levee crown at the crossing

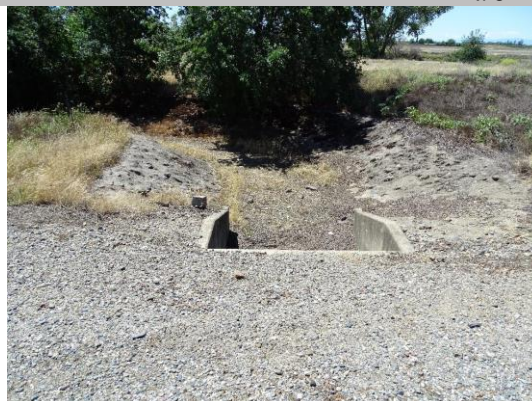
Photo 2 of 3 : UCIP_SP_2020_54134_79661.jpg

View of WS

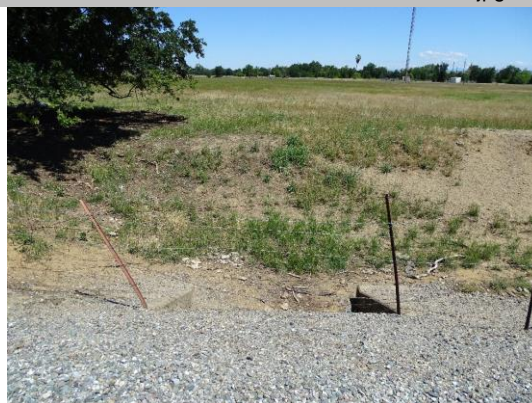
Photo 3 of 3 : UCIP_SP_2020_54134_79662.jpg

View of LS

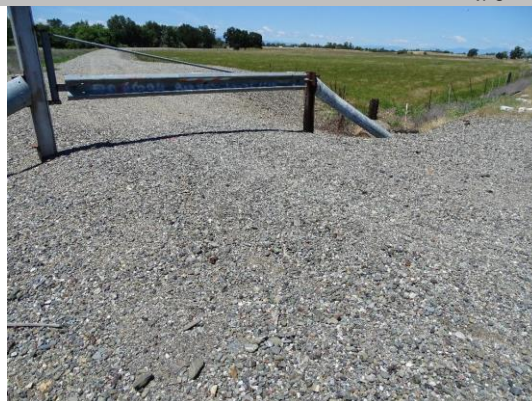
Photo 1 of 3 : UCIP_SP_2020_54135_79666.jpg

Comment Code					
Inspector Comment					
DS_ID:20788 FS_ID:54135 EP_NO: N/A Repair Type: Non-Urgent Crossing Status: Found UCIP Comments: 5/28/2019 Record updated from No Action Needed to Non-Urgent. No permit has been identified authorizing pipe. (O.Yakimov - DWR UCIP) FIELD_STRUCT_DESC: 24-inch corrugated metal drainage pipe through the levee, 5.9 feet below the crown. Flap gate and concrete U-shaped headwall on the waterside (WS) end. Concrete U-shaped headwall on the landside (LS) end. [Additional Reference(s): DWR Levee Log, 1992, (HLM 2.18). USACE Sacramento O&M Manual 510, March 1957 revised October 1964, (HLM 2.24) Drawing No. 50-4-3622]. FS Date: 5/28/2019 2:44:10 PM

View of levee crown at the crossing

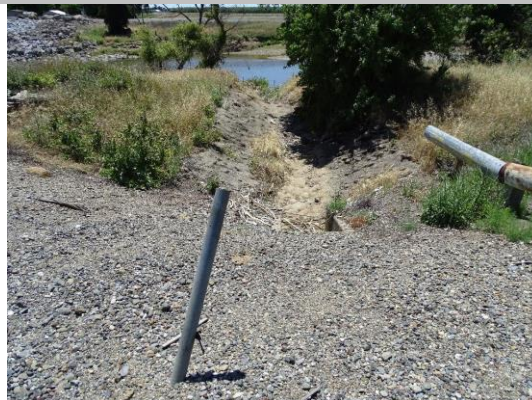
Photo 2 of 3 : UCIP_SP_2020_54135_79667.jpg

View of WS

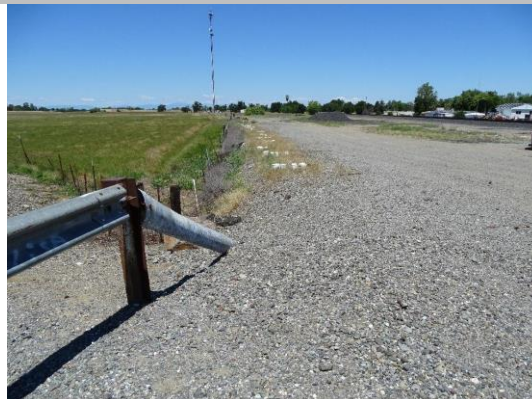
Photo 3 of 3 : UCIP_SP_2020_54135_79669.jpg

View of LS

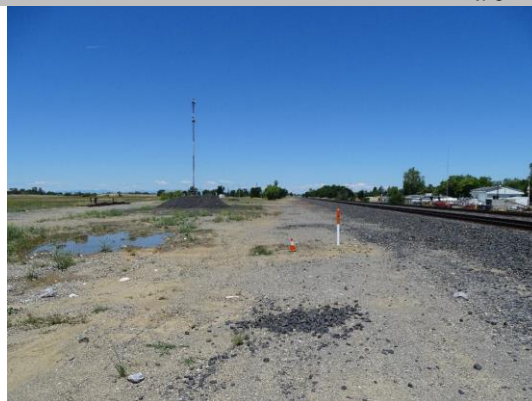
Photo 1 of 3 : UCIP_SP_2020_54136_79673.jpg

DS_ID:24695
 FS_ID:54136
 EP_NO: N/A
 Repair Type: Non-Urgent
 Crossing Status: Indicator Found
 UCIP Comments: 5/28/2019 Record remains Non-Urgent. Found indicators of the crossing. Reclassified crossing status to Indicator Found. (O.Yakimov - DWR UCIP) 10/03/2013 No permit identified for this crossing. (W.Wylie - DWR UCIP)
 FIELD_STRUCT_DESC: Fiber optics conduit of an unknown size or material through the levee, at an unknown depth. Signage on the landside (LS) visible.
 FS Date: 5/28/2019 2:55:24 PM

View of LS with fiber optic line markers

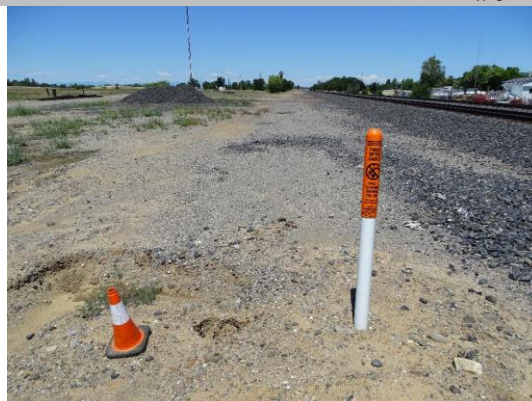
Photo 2 of 3 : UCIP_SP_2020_54136_79672.jpg

Fiber optic line markers on LS

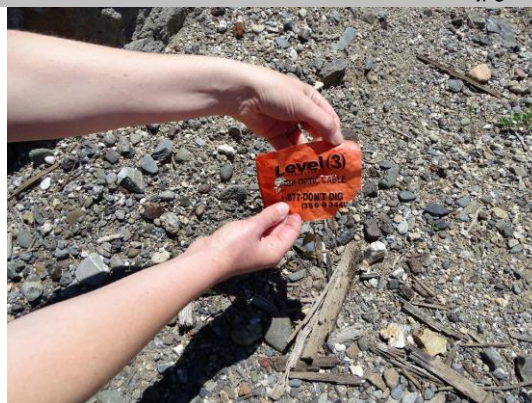
Photo 3 of 3 : UCIP_SP_2020_54136_79674.jpg

An indicator of crossing on WS shoulder

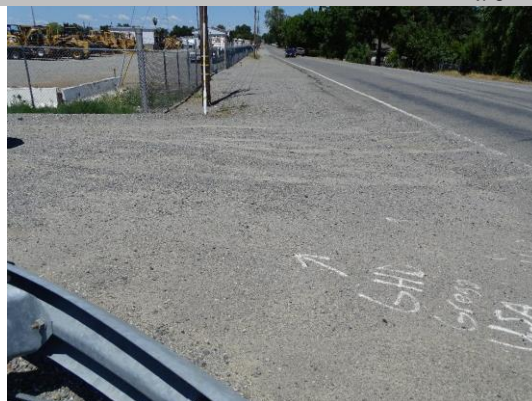
Photo 1 of 3 : UCIP_SP_2020_54137_79677.jpg

LM Start	2.28	Rating **	M	Issue No.	939	
LM End	2.28	Issue Type +	En	Location *		
Category	Supplemental			GPS Latitude/Longitude		
				Start		End
Item	DWR UCIP Field Study			40.052379 °		40.052379 °
				-122.149534 °		-122.149534 °
DWR ID	24694					
Comment Code						
Inspector Comment						
DS_ID:24694 FS_ID:54137 EP_NO: N/A Repair Type: Non-Urgent Crossing Status: Found UCIP Comments: 5/28/2019 Record remains Non-Urgent. No inspection records were available to determine status of line through the levee. No permit for this crossing was found. (O.Yakimov - DWR UCIP) 10/03/2013 No permit identified for this crossing. (W.Wylie - DWR UCIP) FIELD_STRUCT_DESC: 4-inch coated steel gas pipeline through the levee, 3.5 feet below the crown. Pipe visible on upstream side of bridge. FS Date: 5/28/2019 3:08:00 PM

Levee crown at crossing

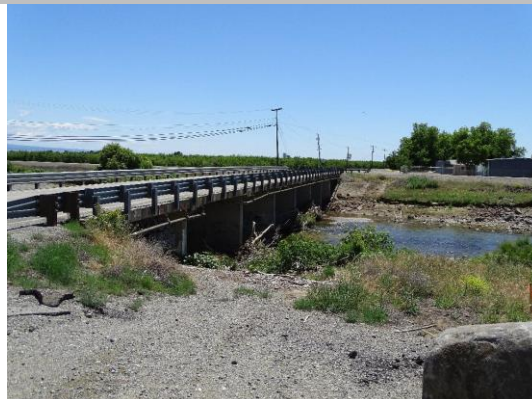
Photo 3 of 3 : UCIP_SP_2020_54137_79679.jpg

View of San Benito Ave bridge with pipe attached

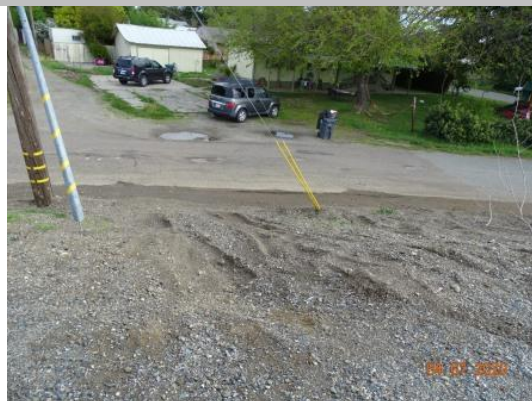
Photo 1 of 1 : SP_2020_NA0019_81_12_20200413_00086.jpg

LM Start	2.32	Rating **	M	Issue No.	12
LM End	2.32	Issue Type +	Ma	Location *	LS
Category	Earthen Levee			GPS Latitude/Longitude	
				Start	End
Item	Slope Stability			40.052443 °	40.052443 °
				-122.148863 °	-122.148863 °
DWR ID	DWR_NA0019_04_f_2013_12				
Comment Code					
S3 : Repair the levee slope damaged by vehicle traffic and prevent access where possible.					
Inspector Comment

View of the damaged landside slope caused by vehicle traffic. Spring 2020.

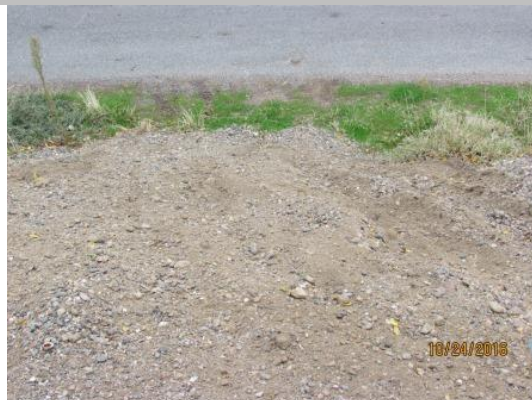
Photo 1 of 1 : SP_2020_NA0019_81_30_20200226_00011.jpg

LM Start	2.35	Rating **	M	Issue No.	30
LM End	2.35	Issue Type +	Ma	Location *	LS
Category	Earthen Levee			GPS Latitude/Longitude	
				Start	End
Item	Slope Stability			40.052450 °	40.052450 °
				-122.148352 °	-122.148352 °
DWR ID	DWR_NA0019_04_f_2016_30				
Comment Code					
S3 : Repair the levee slope damaged by vehicle traffic and prevent access where possible.					
Inspector Comment

View of the slope instability caused by vehicles along the landside slope.

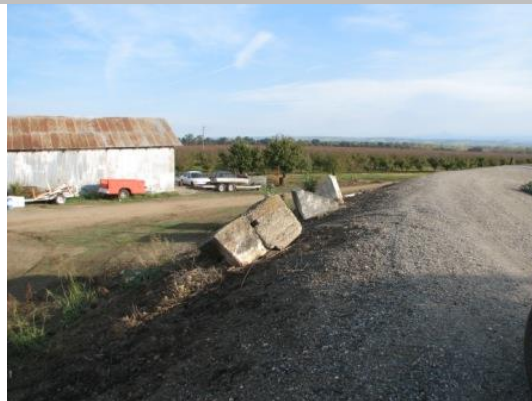
Photo 1 of 1 : SP_2020_NA0019_81_1_20200226_00001.jpg

LM Start	3.11	Rating **	M	Issue No.	1
LM End	3.13	Issue Type +	En	Location *	LS
Category	Earthen Levee			GPS Latitude/Longitude	
				Start	End
Item	Encroachments			40.057083 °	40.057291 °
				-122.137935 °	-122.137743 °
DWR ID	DWR_NA0019_04_s_2012_1				
Comment Code					
DE : Debris					
Inspector Comment					
Remove concrete blocks, concrete pipes, and concrete stairs from the landside slope.

View of the concrete stairways on the slope.

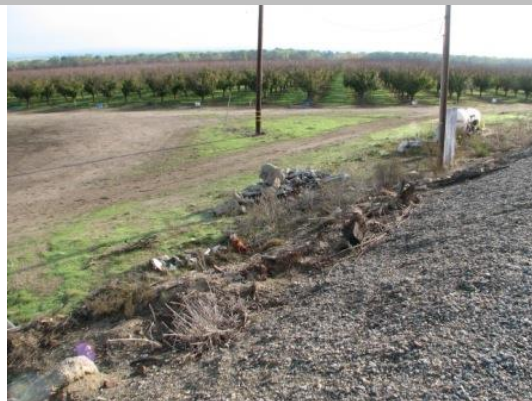
Photo 1 of 1 : SP_2020_NA0019_81_6_20200226_00005.jpg

LM Start	3.31	Rating **	M	Issue No.	6
LM End	3.31	Issue Type +	En	Location *	LS
Category	Earthen Levee			GPS Latitude/Longitude	
				Start	End
Item	Encroachments			40.057558 °	40.057558 °
				-122.134417 °	-122.134417 °
DWR ID	DWR_NA0019_04_s_2012_6				
Comment Code					
GA : Garbage					
Inspector Comment

View of the garbage and metal along the landside slope and toe of the levee.

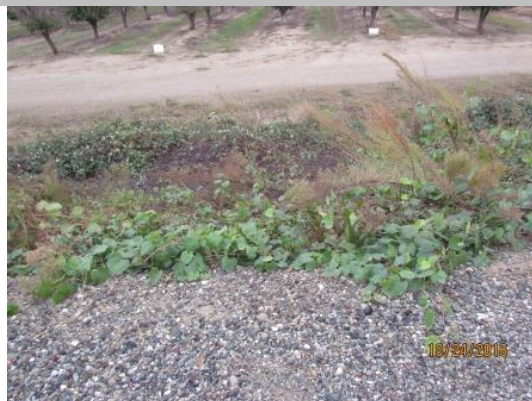
Photo 1 of 1 : SP_2020_NA0019_81_39_20200226_00013.jpg

LM Start	3.40	Rating **	M	Issue No.	39
LM End	3.44	Issue Type +	Ma	Location *	LS
Category	Earthen Levee			GPS Latitude/Longitude	
				Start	End
Item	Vegetation			40.056546 °	40.055906 °
				-122.133530 °	-122.133294 °
DWR ID	DWR_NA0019_04_f_2016_39				
Comment Code					
V2 : Remove the wild growth other than native grasses from the levee slopes.					
Inspector Comment

View of the blackberries along the landside slope blocking visibility and access.

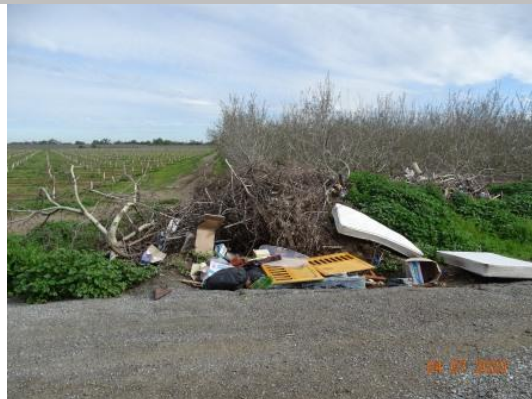
Photo 1 of 1 : SP_2020_NA0019_81_21_20200413_00088.jpg

LM Start	3.66	Rating **	U	Issue No.	21
LM End	3.66	Issue Type +	En	Location *	LS
Category	Earthen Levee			GPS Latitude/Longitude	
				Start	End
Item	Encroachments			40.055735 °	40.055735 °
				-122.129445 °	-122.129445 °
DWR ID	DWR_NA0019_04_s_2015_21				
Comment Code					
PR : Prunings					
Inspector Comment					
Remove the prunings and garbage from the landside toe.

View of the prunings and other debris along the landside slope. Spring 2020.

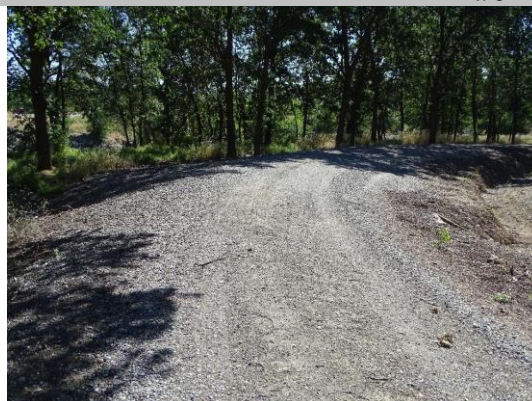
Photo 1 of 3 : UCIP_SP_2020_54066_79377.jpg

View of levee crown at crossing

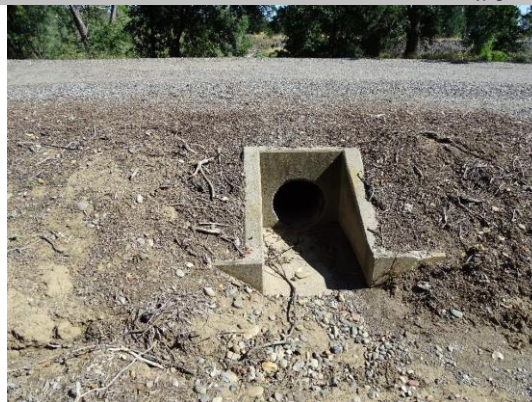
Photo 2 of 3 : UCIP_SP_2020_54066_79378.jpg

View of headwall at LS toe

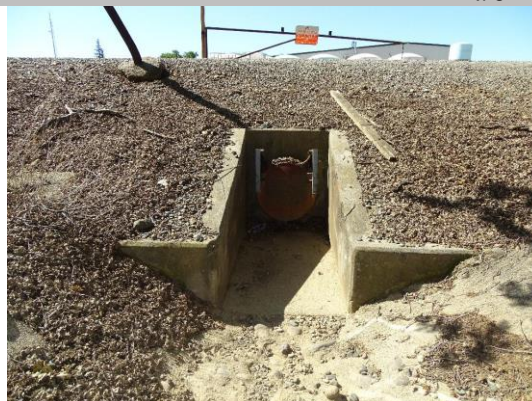
Photo 2 of 3 : UCIP_SP_2020_54069_79395.jpg

Headwall at WS toe

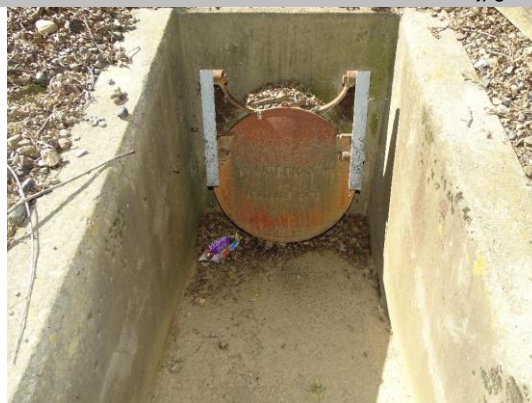
Photo 3 of 3 : UCIP_SP_2020_54069_79396.jpg

Flap gate at WS toe

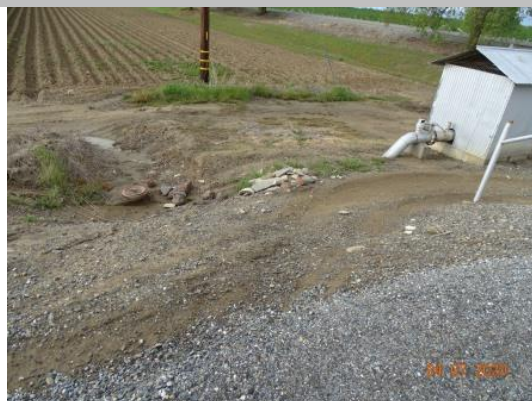
Photo 1 of 1 : SP_2020_NA0019_82_12_20200413_00021.jpg

LM Start	1.28	Rating **	M	Issue No.	12
LM End	1.28	Issue Type +	Ma	Location *	LS
Category	Earthen Levee			GPS Latitude/Longitude	
				Start	End
Item	Slope Stability			40.051330 °	40.051330 °
				-122.169817 °	-122.169817 °
DWR ID	DWR_NA0019_05_s_2020_12				
Comment Code					
S3 : Repair the levee slope damaged by vehicle traffic and prevent access where possible.					
Inspector Comment

View of the landside slope instability due to vehicle traffic. Spring 2020.

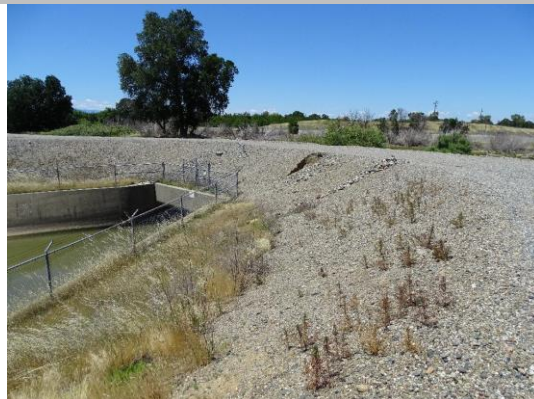
Photo 1 of 3 : UCIP_SP_2020_54060_79348.jpg

LM Start	1.83	Rating **	U	Issue No.	22
LM End	1.83	Issue Type +	En	Location *	
Category	Supplemental			GPS Latitude/Longitude	
				Start	End
Item	DWR UCIP Field Study			40.052313 °	40.052313 °
				-122.160085 °	-122.160085 °
DWR ID	20795				
Comment Code					
Inspector Comment					
DS_ID:20795 FS_ID:54060 EP_NO: N/A Repair Type: Urgent Crossing Status: Found UCIP Comments: 5/28/2019 Record updated to Urgent. No permit has been identified authorizing pipe. Subsidence on LS slope near pipe alignment more than a foot in depth. (O.Yakimov - DWR UCIP) FIELD_STRUCT_DESC: [Tehama and Colusa Canal] 18.5-foot reinforced concrete irrigation siphon pipe through the levee, 30 feet below the crown. 1.5-foot by 2-foot electrical conduit box on the landside (LS) slope. [Additional Reference(s): DWR Levee Log, 1992 (HLM 1.86)]. FS Date: 5/28/2019 7:24:30 AM

Subsidence on LS slope just downstream of pipe alignment

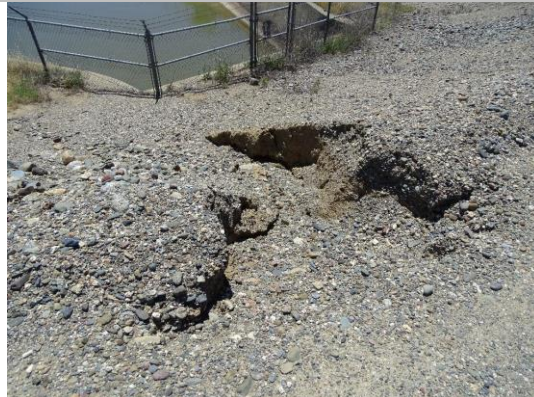
Photo 2 of 3 : UCIP_SP_2020_54060_79349.jpg

Closeup view of subsidence on LS slope

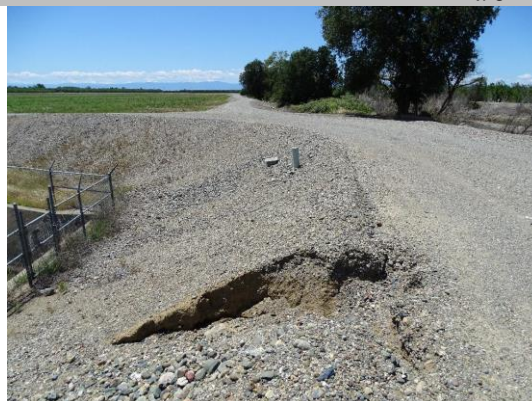
Photo 3 of 3 : UCIP_SP_2020_54060_79350.jpg

View of LS slope at the crossing

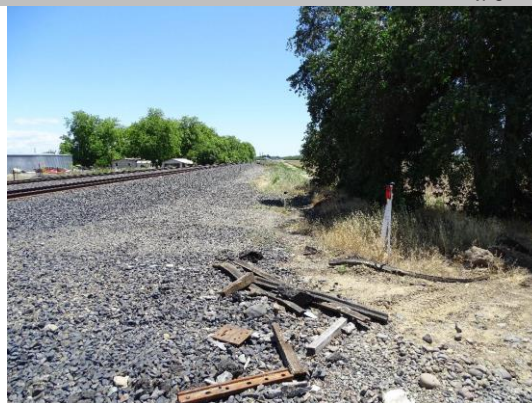
Photo 1 of 3 : UCIP_SP_2020_54079_79412.jpg

DS_ID:24692
 FS_ID:54079
 EP_NO: N/A
 Repair Type: Non-Urgent
 Crossing Status: Found
 UCIP Comments: 5/28/2019 Record remains Non-Urgent. No permit for this crossing was found. (O.Yakimov - DWR UCIP) 10/03/2013 No permit identified for this crossing. (W.Wylie - DWR UCIP)
 FIELD_STRUCT_DESC: Steel fiber optics conduit of an unknown size through the levee, at an unknown depth. Sign markers on the landside (LS) shoulder.
 FS Date: 5/28/2019 2:53:47 PM

Landside view with markers installed

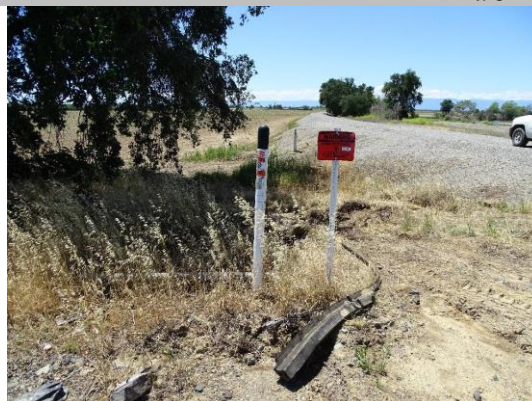
Photo 2 of 3 : UCIP_SP_2020_54079_79413.jpg

Fiber optic line markers on LS shoulder

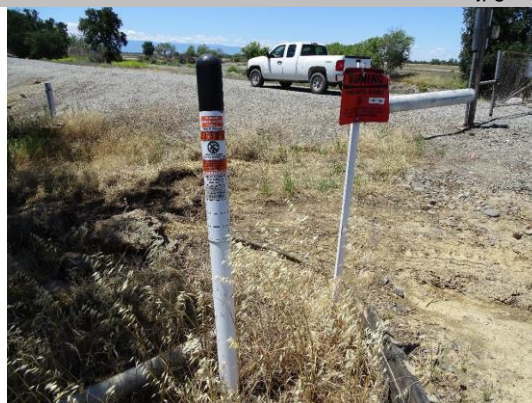
Photo 3 of 3 : UCIP_SP_2020_54079_79414.jpg

Closeup view of fiber optic line markers

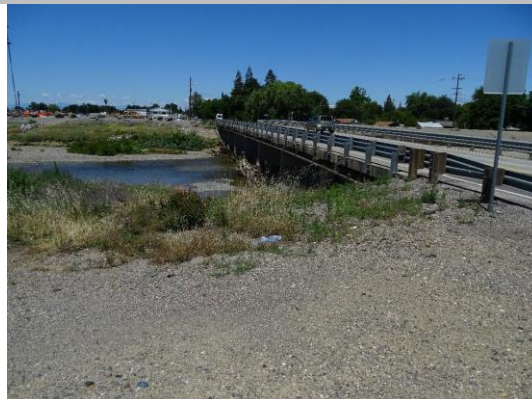
Photo 1 of 3 : UCIP_SP_2020_54083_79415.jpg

LM Start	2.47	Rating **	M	Issue No.	24
LM End	2.47	Issue Type +	En	Location *	
Category	Supplemental			GPS Latitude/Longitude	
				Start	End
Item	DWR UCIP Field Study			40.051667 °	40.051667 °
				-122.149033 °	-122.149033 °
DWR ID	24693				
Comment Code					
Inspector Comment					
DS_ID:24693 FS_ID:54083 EP_NO: N/A Repair Type: Non-Urgent Crossing Status: Found UCIP Comments: 5/28/2019 Record remains Non-Urgent. No inspection records were available to determine status of line through the levee. No permit for this crossing was found. Minor runoff erosion between the bridge and WS slope at the place where crossing daylight. (O.Yakimov - DWR UCIP) 10/03/2013 No permit identified for this crossing. (W.Wylie - DWR UCIP) FIELD_STRUCT_DESC: 4-inch steel gas pipeline through the levee, 2.5 feet below the crown. Pipe visible on upstream side of bridge. FS Date: 5/28/2019 3:02:30 PM

View of gas pipeline attached to upstream side of bridge

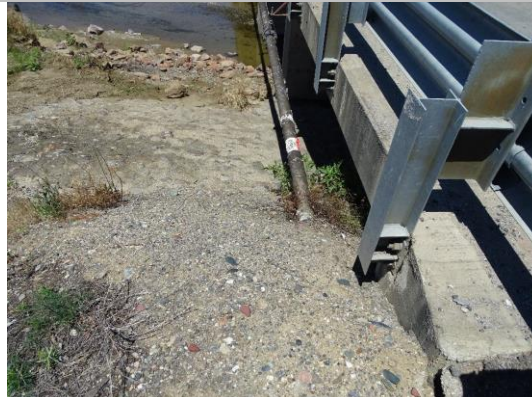
Photo 2 of 3 : UCIP_SP_2020_54083_79416.jpg

View of WS slope at crossing

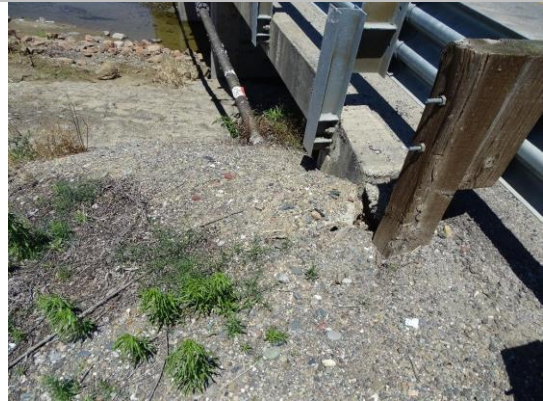
Photo 3 of 3 : UCIP_SP_2020_54083_79417.jpg

Minor runoff erosion at the bridge and WS slope
